Proposed Conservation Plan of Sri Ram Chandra Library Complex in Baripada, Odisha

Department of Architecture and Regional Planning
IIT Kharagpur

15 October 2025

Part 1- Status Report

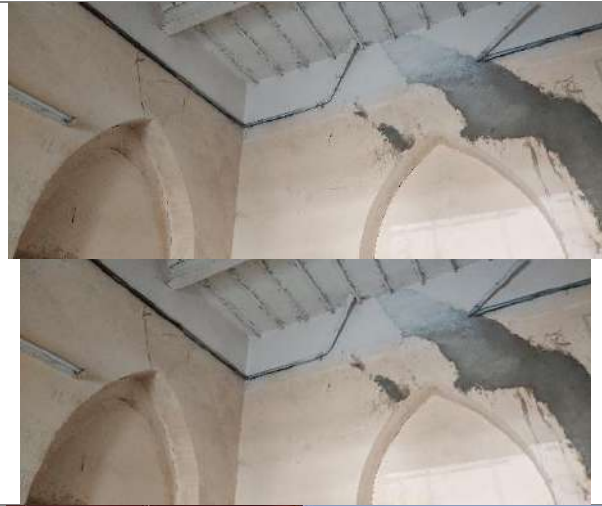
Cracks in walls: Visible cracks are present in various sections, particularly near the keystones, corners, and around the openings (windows and doors).

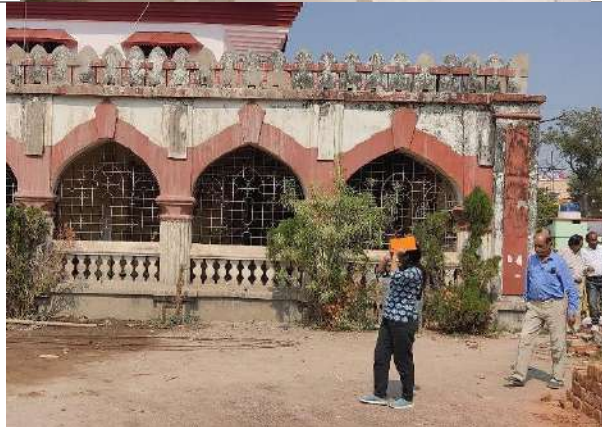
Tilting of east wall: The east wall seems tilted, indicating structural distress.

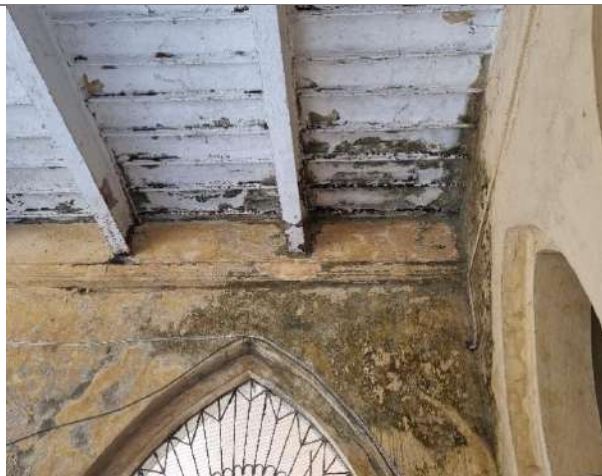
Dampness in walls: Rising moisture resulted into dampness of the surfaces and formation of mosses in the affected areas.

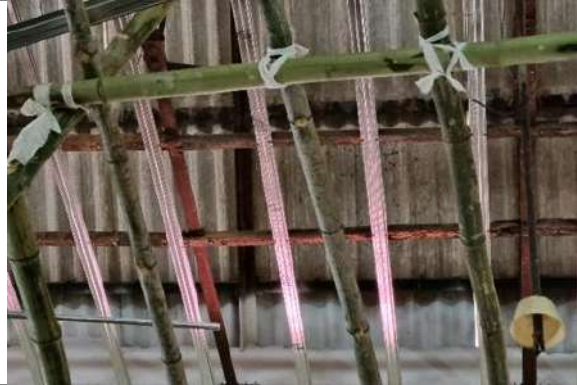
Roof and trusses: The roof structure and trusses showed signs of rusting and charring, requiring

urgent attention. Additionally, it was observed that the ongoing false ceiling work at site, attempts to cover up the real structural damage of the building.

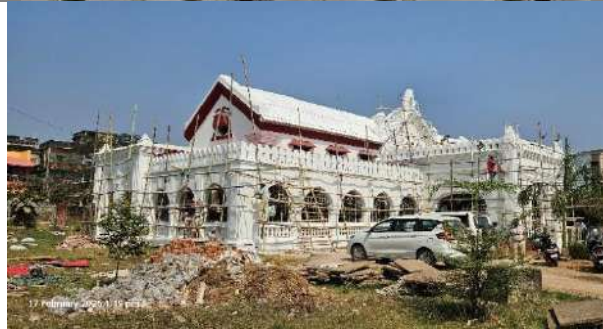
Wall Putty: External wall surface treatment with putty over lime plaster was observed.

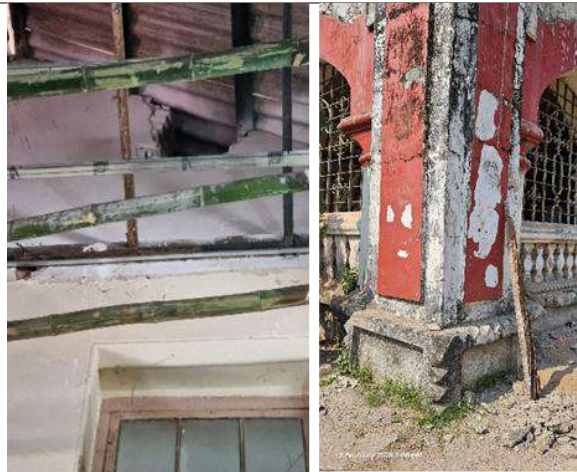
Wall material (Plaster): Many walls exhibited deterioration, with original plaster (lime) falling off in several areas. Many portions have been repaired over the years using cement mortar (which does not bind well with the lime mortar).

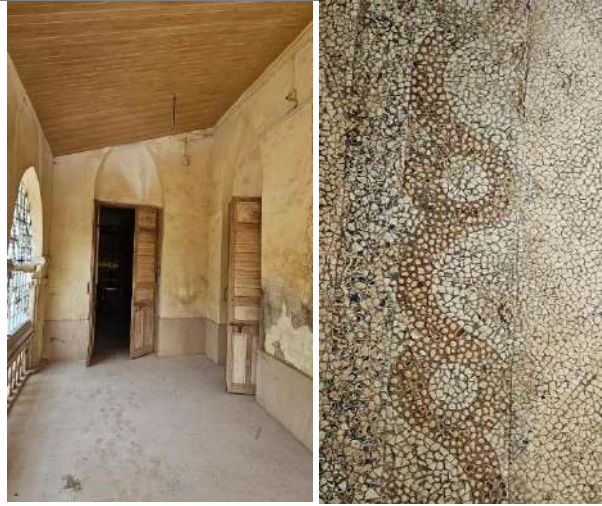
Flooring: The original ceramic mosaic flooring has been altered with vitrified tiles.

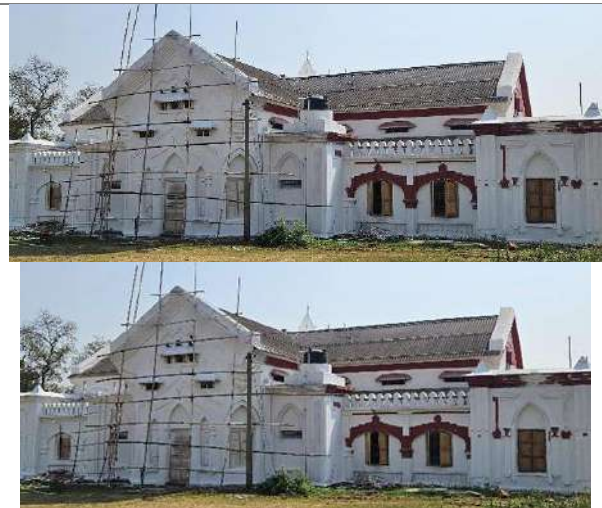
Louvre doors and windows: There has been alteration in the windows. Classical louvred windows are replaced with ordinary board and batten windows.

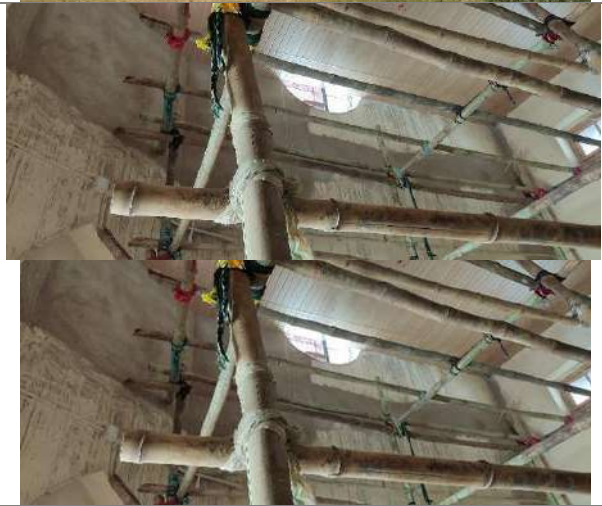
Rose windows (upper-level circular ventilators) are suppressed by the newly added false ceiling. The closed doors and windows, added with the upcoming false ceiling contributing to minimum ventilation (reduction in ceiling height) and daylighting.

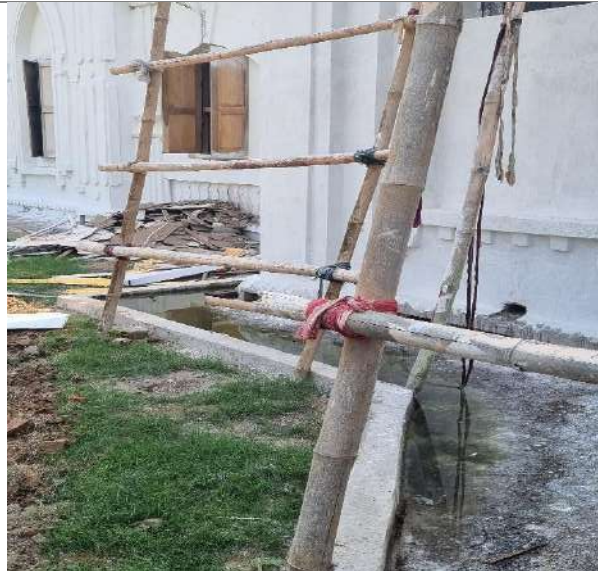
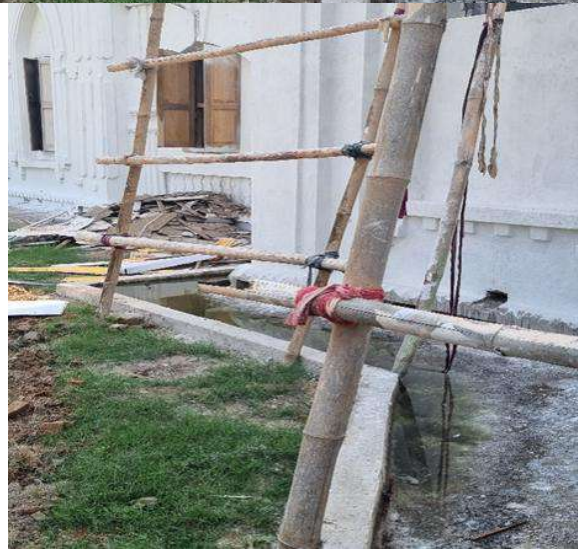
Moisture Penetration: Waterlogging was noted at the building perimeter due to the concretization; lack of proper drainage further contributed to rise in dampness and structural weakening.

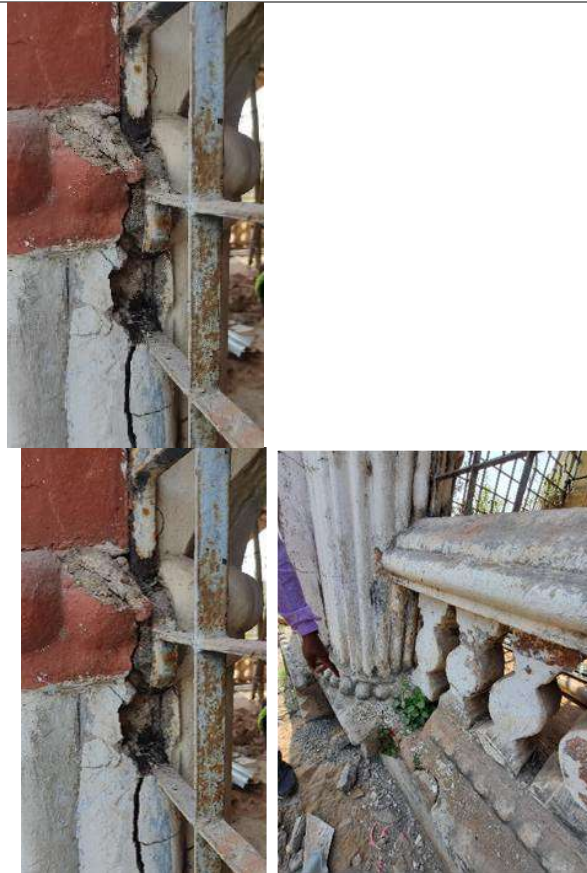
Rusting of Metal Grills: The metal grills have developed rust, leading to additional crack formations in the adjoining walls.

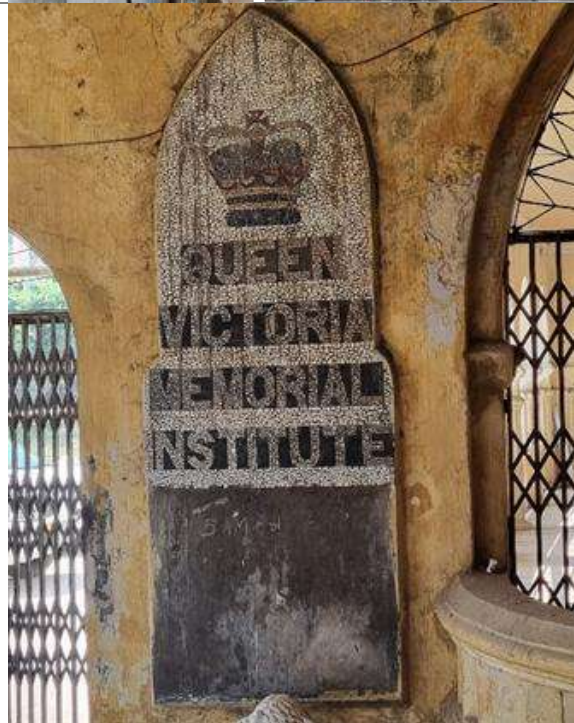
Tampered landmark nameplate: The landmark nameplates near the entrance have been insensitively altered by adding a blackboard ruining the enriched mosaic finish of the heritage building.

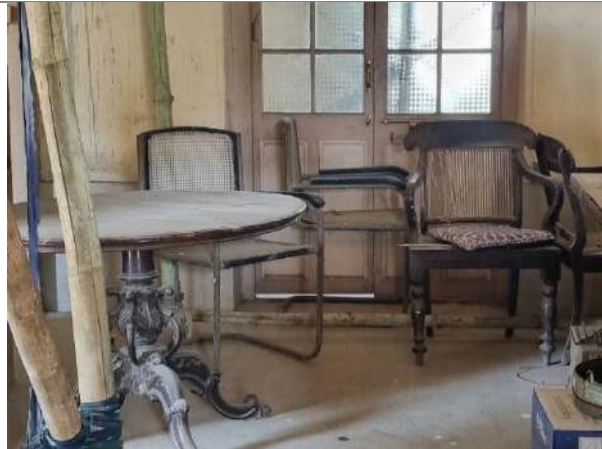
Antique furniture: The furniture is of antique value. However, they are damaged, left carelessly and unaccounted.

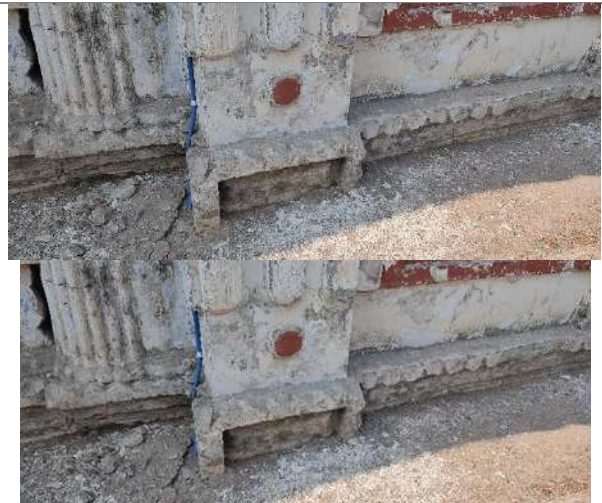
Damage of architectural works: Intricate curved mouldings on plinth wall are damaged and suppressed due to concretization.

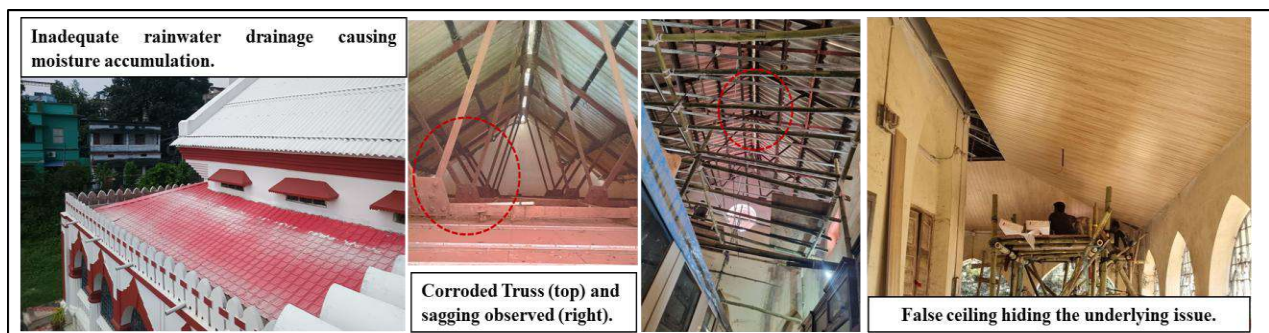
Figure 2: Current Roofing Condition

- **Roof and Truss:** The building's roof is mainly of corrugated sheets supported by truss systems. Rusting and sagging of truss members has been observed. Original clay tiles with timber truss have been replaced.
- **False Ceiling:** interior ceiling has been newly added which is concealing the existing damage and not addressing the structural issues.

- **Roof and Truss:** Removing all the sheets and damaged trusses. inappropriate replacements have been carried out hence, these should be restored back to the original and authentic roofing materials.
Materials: Reintroducing clay tiles and using galvanized steel trusses as they are more durable.
- **False Ceiling:** Removal of false ceiling panels and restoring original ceiling with lime plaster repair work.
- **Roof water Management:** continuous corrosion resistant gutters to be provided at the eaves and valley lines to prevent leakage and carried to the drains along plinth protection. The water collected from the gutters can be channelized to the proposed retention basin in the eastern side of the site.

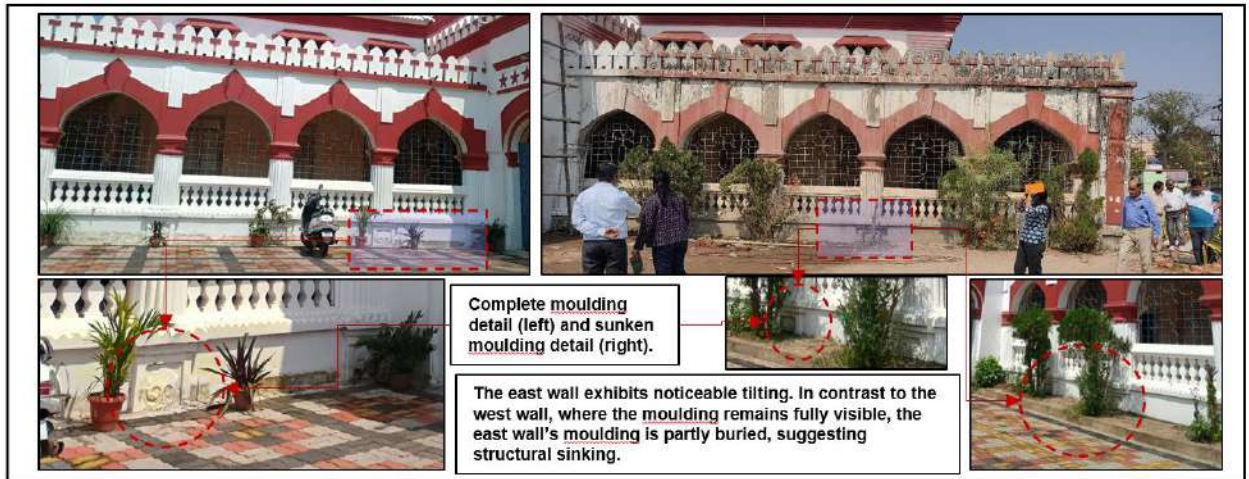
Figure 3: Structural settlement of east wall

The walls exhibit localized sinking, particularly from one corner, resulting in visible tilting of the east wall. This indicates settlement or movement in the foundation and poses significant structural distress.

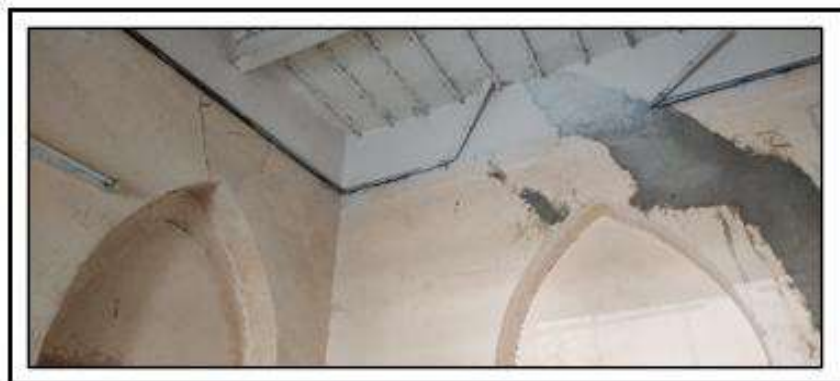
Figure 4: Cracks in the walls

Cracks are present near keystones, corners, and around openings such as windows and doors. Such patterns suggest stress concentration and possible foundation instability.

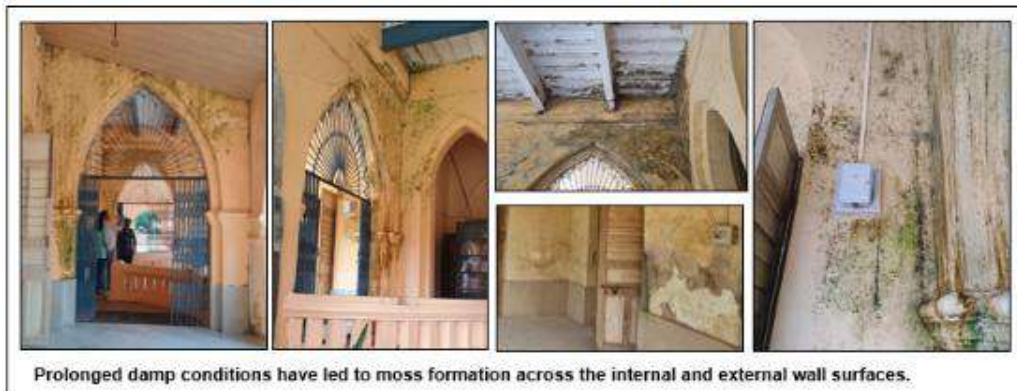
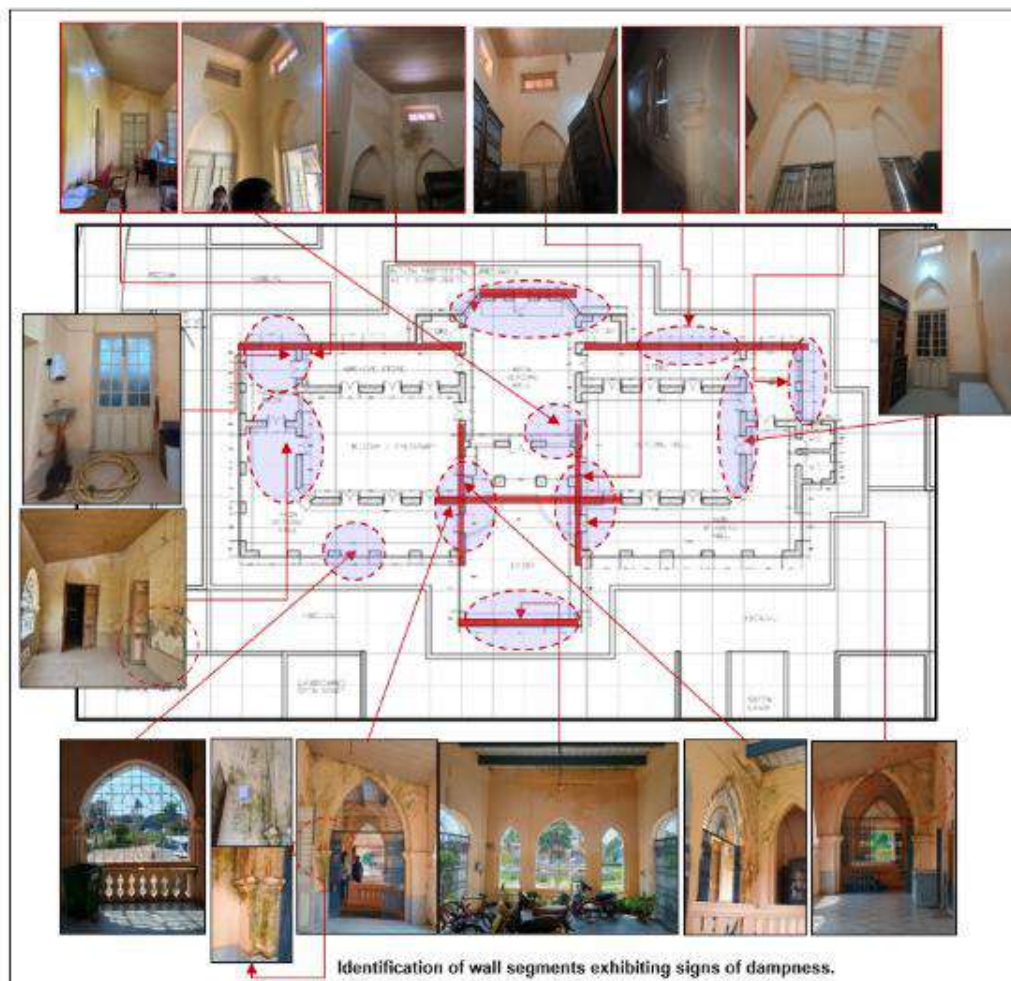
Figure 5: Identification of Problem Areas

Dampness is prevalent throughout the wall surfaces, leading to moss formation in affected zones.

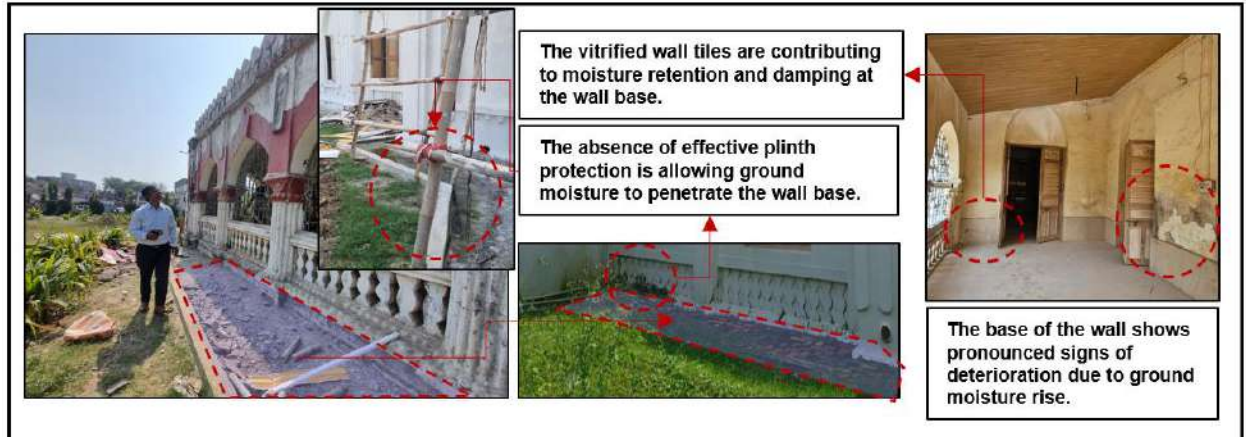
Figure 6: Damping source at ground level

Concretization and inadequate drainage around the building perimeter has caused waterlogging. The absence of plinth protection is allowing moisture ingress through peripheral paver blocks, further exacerbating both structural and moisture issues.

Provide a continuous 1.8 m wide plinth protection along the building perimeter, supplemented by a drainage gutter to direct water away from the foundation.

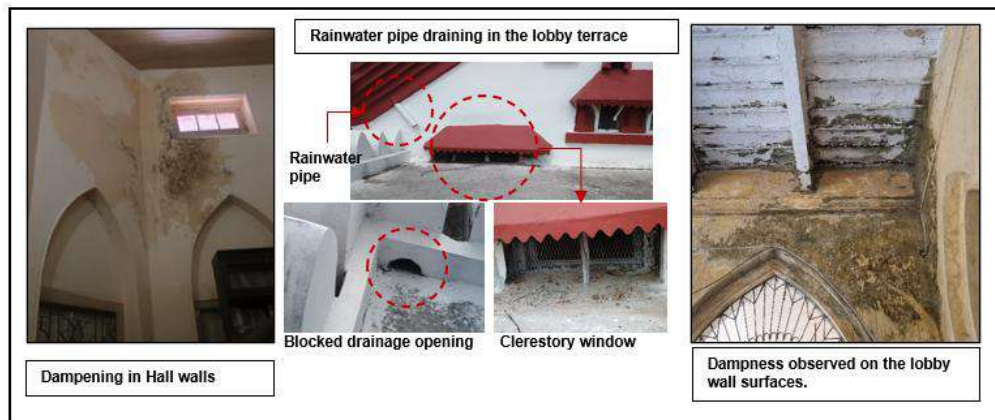
Rainwater from the upper roof tier is being directed and accumulated onto the lobby roof. Due to the blocked drainage openings and the window directly exposed to the slab surface, water becomes trapped on the roof. Additionally, seepage from the clerestory window penetrates between the concrete (impervious layer) and the lime plaster (porous layer), resulting in prolonged dampness and moisture retention within the roof assembly.

Figure 7: Roof-Level Water Entrapment - Cause (Centre) and Effect (Left & Right)

Remove the concrete layer from the roof, and ensure that window openings are unobstructed, allowing for cross-ventilation and natural drying of internal spaces.

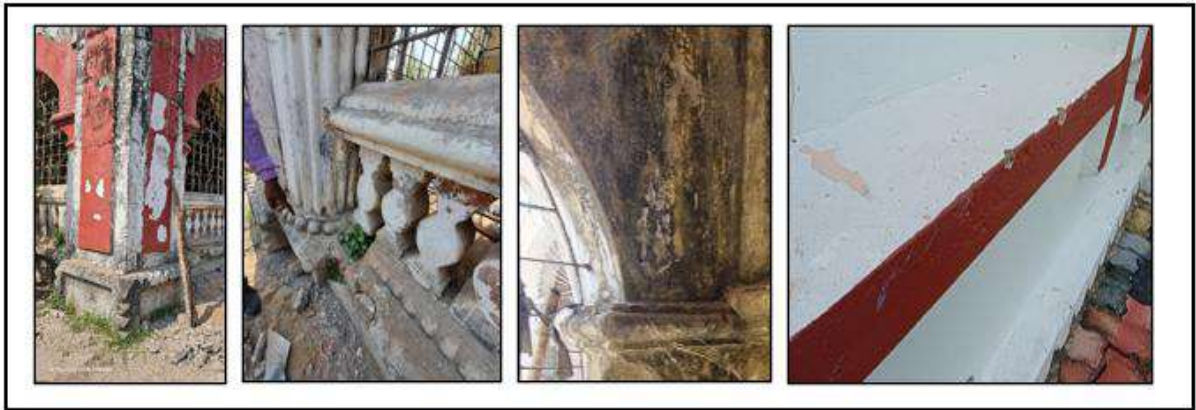
Figure 8: Plaster deterioration

Several wall sections display falling-off and degraded lime plaster. Over time, repairs have been performed using cement mortar, which does not adhere well to original lime mortar substrates.

Strip all non-original plaster layers, clear deteriorated surfaces, and reapply fresh lime mortar to restore wall breathability and minimize further dampness.

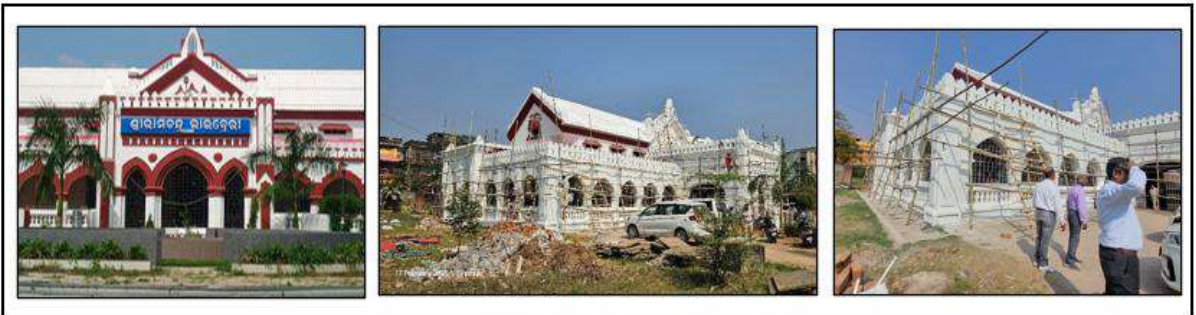
External walls finished with non-breathable white putty and plastic paint over lime plaster restrict moisture evaporation, aggravating existing dampness.

Figure 9: White putty treatment on the surface topped with plastic paint

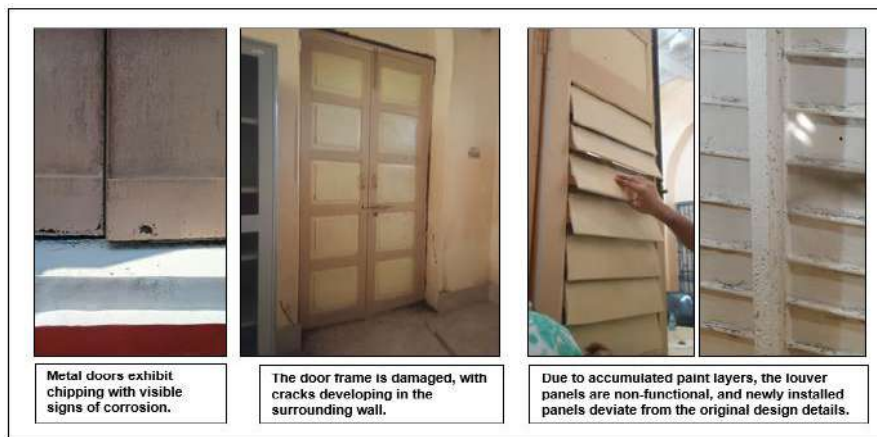
Condition: Doors with solid wood and glass panels are modifications, while the original louvered doors have largely lost functionality due to multiple layers of paint. In some cases, new louver panels were added with different section details, making them decorative rather than functional. Additionally, wooden frames at several locations exhibit cracks, localized decay, and general wear.

Figure 11: Problems arising in the current doors and openings.

A detailed door schedule should be prepared to document all existing types. Only the original louvered doors (Type A) should be retained to restore uniformity and preserve the cultural and architectural significance. Old paint should be carefully removed, damaged areas infilled with appropriate wood filler, and the doors repainted to prevent further deterioration.

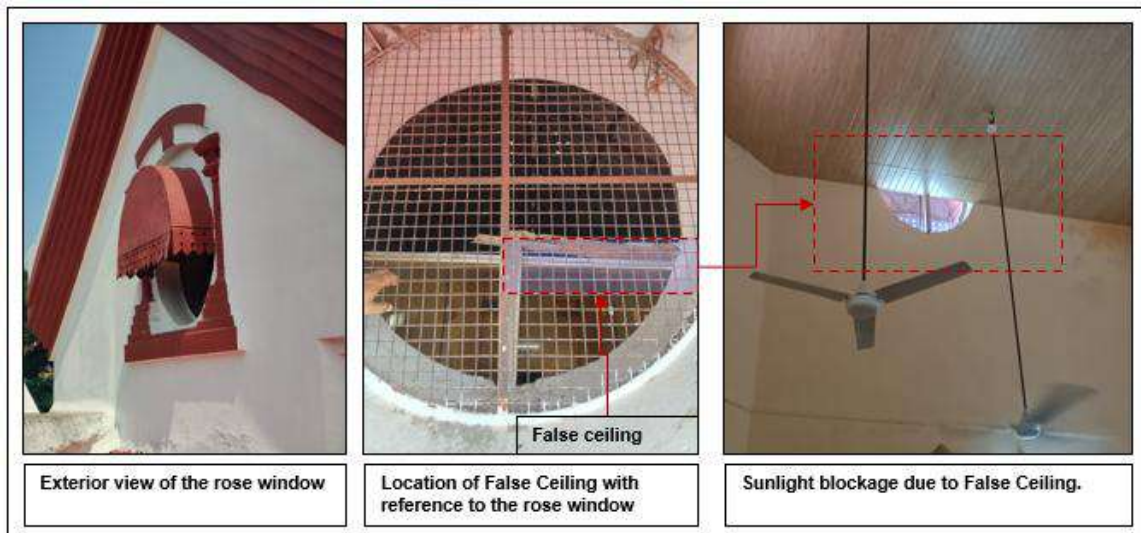
Figure 12: Rose Window and the false ceiling

- **Rose windows** (upper-level circular ventilators) are suppressed by the newly added false ceiling. The closed doors and windows, added with the upcoming false ceiling contributing to minimum ventilation (reduction in ceiling height) and daylighting.

The false ceiling conceals the rose windows, diminishing their architectural prominence and visual grandeur. It is recommended that the rose windows be left open to restore both natural light and ventilation within the space.

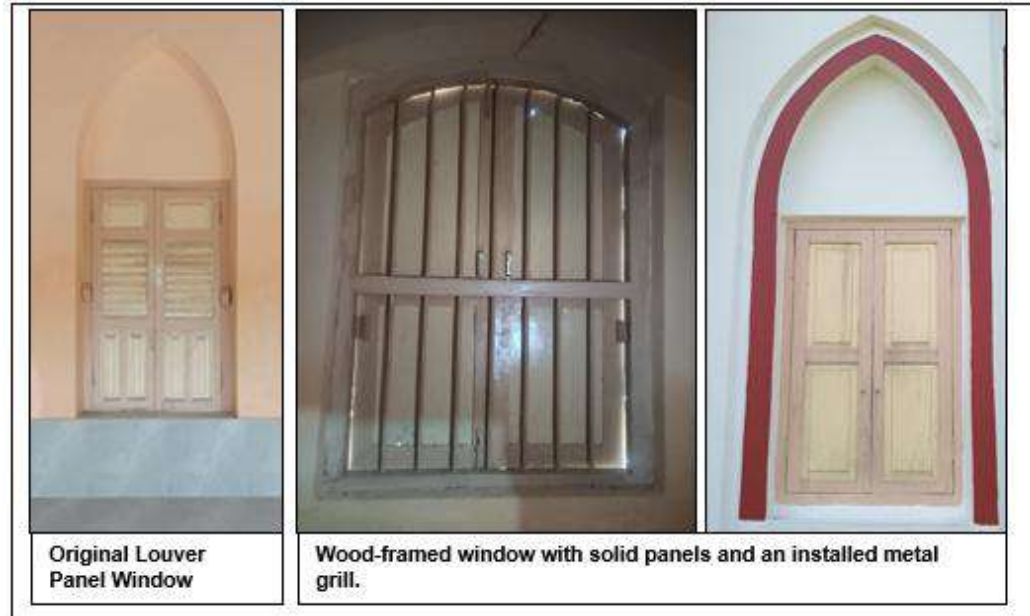
Figure 13:Windows as observed

Over time, original louvered windows have largely lost functionality due to multiple layers of paint. In some cases, new louver panels were added with different section details, rendering them decorative rather than functional. Additionally, wooden frames at several locations exhibit cracks, localized decay, and general wear.

Clerestory windows feature metal jalis that show signs of damage and corrosion, requiring repair and repainting to restore both function and aesthetics.

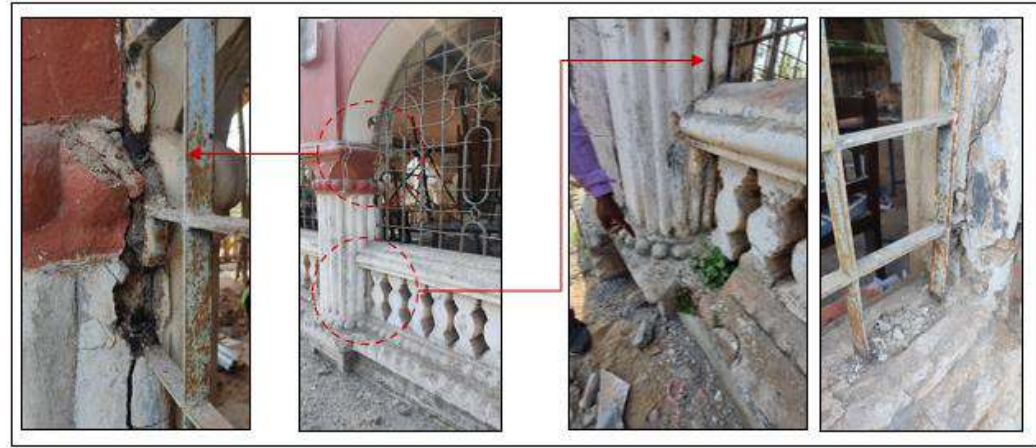
Condition: Several windows and arch openings have metal grills installed, which have developed rust over time. This corrosion has contributed to additional cracking in the adjoining walls.

Figure 14: Corrosion of metal grill causing cracking in the adjoining wall

Recommendation: All such additional grills should be removed from window openings to protect the original structure and prevent further damage. Additional grills that are installed need to be removed from the window openings.

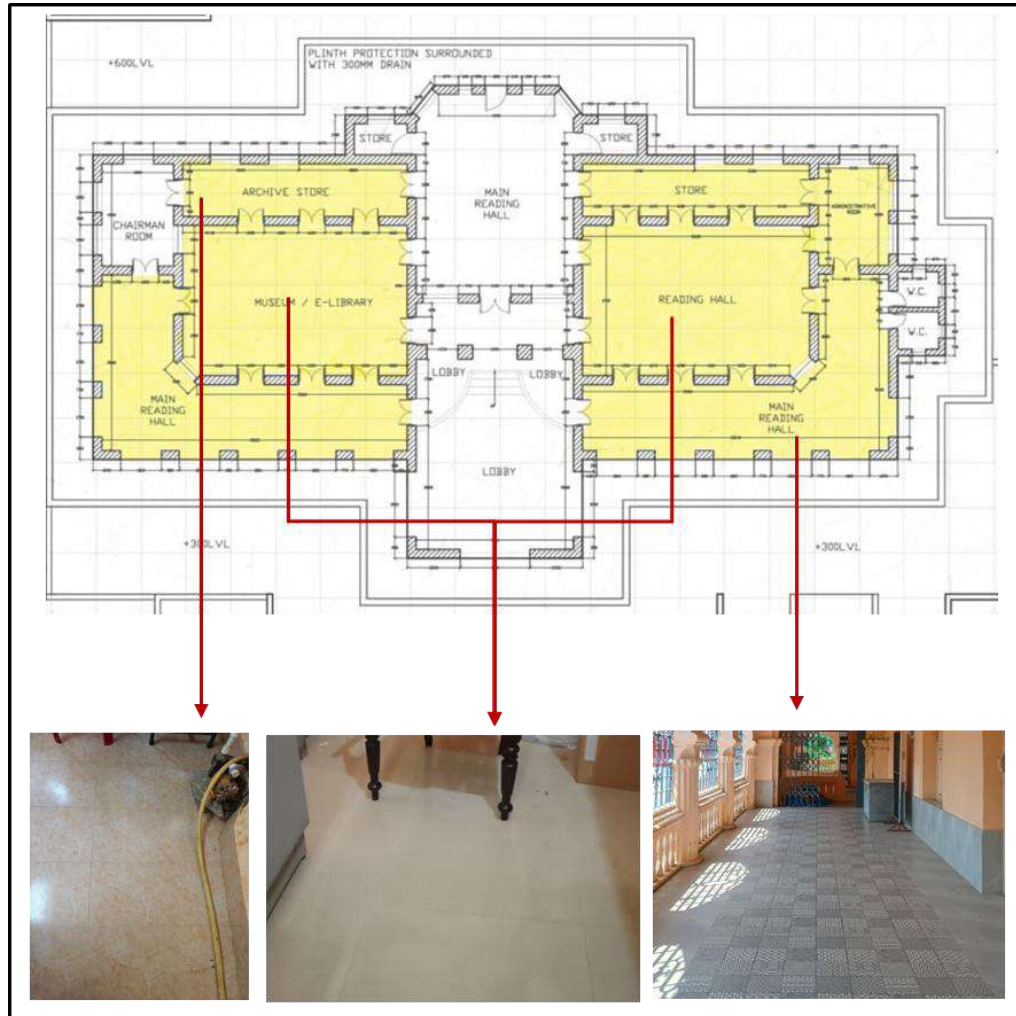
The original mosaic flooring has been altered in different areas and has been replaced with vitrified tiles. In many years the flooring has experienced surface wear over time and loss in pattern.

Figure 16: Map showing locations of new tiles

- Removing all the non-original vitrified tiles and replacing them again with mosaic pieces set in lime mortar.
- Wherever replacing is not possible,
- Repairing, or relaying the original flooring. All re-laying, fixing, and bedding to be carried out with traditional lime mortar. Wherever replacement is unavoidable, sourcing similar materials.

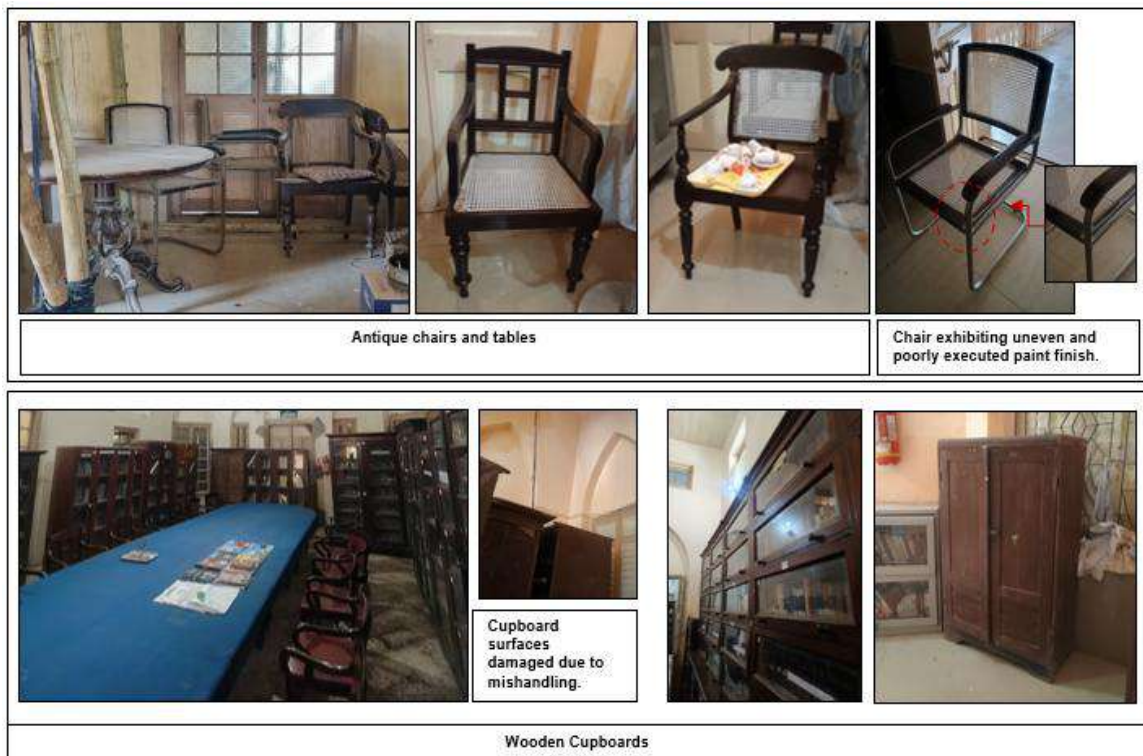
Figure 17:Antique furniture

Structurally, the furniture is generally sound, and the original wood remains in good condition. Nevertheless, the care and maintenance of these pieces have been inadequate. The original cane infill chairs are particularly affected, with cane either torn or missing. In many cases, plywood has been used to replace the cane, compromising the original aesthetic and design integrity. Additionally, the original wood grain and finish have been obscured due to surface painting, further diminishing the furniture's historical and visual value.

Recommendation: The antique furniture should be carefully restored to preserve its heritage value and design integrity. Damaged cane infills must be replaced with traditional handwoven cane instead of plywood to retain authenticity. Existing paint layers should be gently stripped

to reveal the original wood grain, followed by surface treatment with natural oils or polish to protect and enhance the material. Structural joints and components showing wear should be repaired using compatible wood and joinery techniques. A regular maintenance routine, including cleaning, polishing, and protection from moisture and sunlight, should be established. Finally, all furniture pieces should be properly documented through inventory and photographs to ensure accountability and guide future conservation efforts.

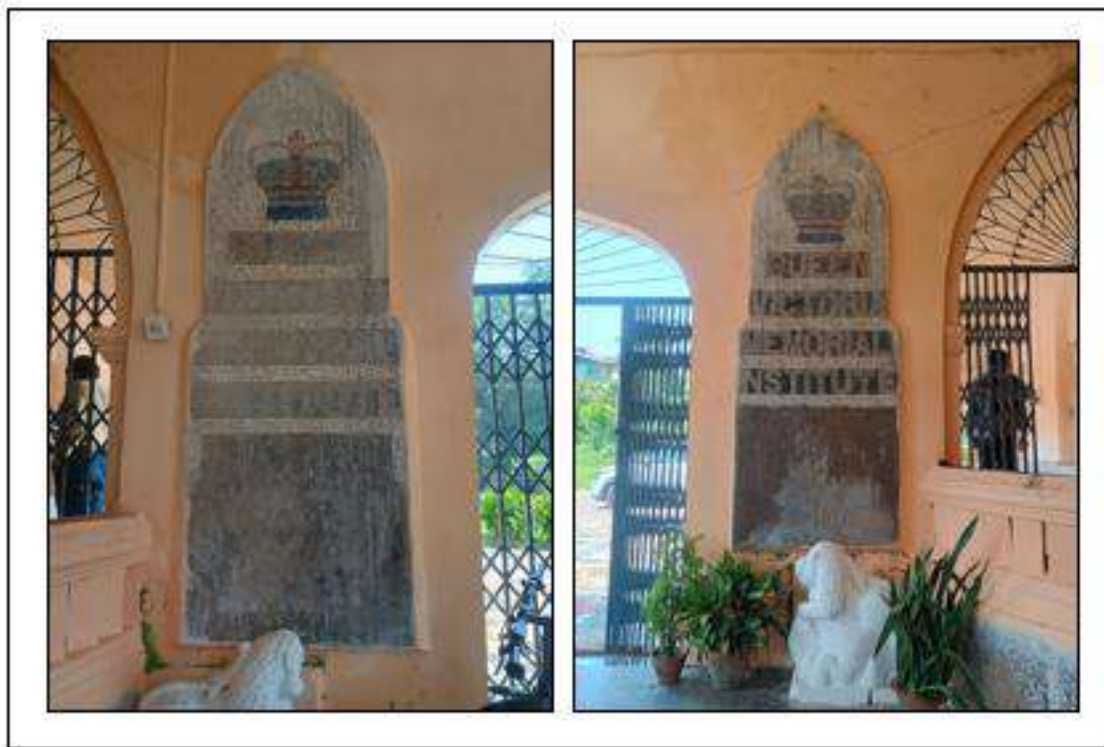
Figure 18: Landmark Nameplate

The landmark mosaic nameplates near the entrance have been insensitively altered by the addition of a blackboard, compromising the original design and obscuring the intricate mosaic finish. Years of neglect have further led to cement deposition, surface deterioration, and loss of visual clarity.

Recommendation: The mosaic nameplate should be carefully cleaned using non-abrasive methods to remove cement deposits and surface grime. Damaged or missing tesserae must be repaired with matching materials and lime-based mortar. The surface should then be treated with a pH-neutral cleaner and sealed with a breathable protective coating.
