Proposed Conservation Plan of Sri Ram Chandra Library Complex in Baripada, Odisha

Department of Architecture and Regional Planning
IIT Kharagpur

15 October 2025

Part 1- Status Report

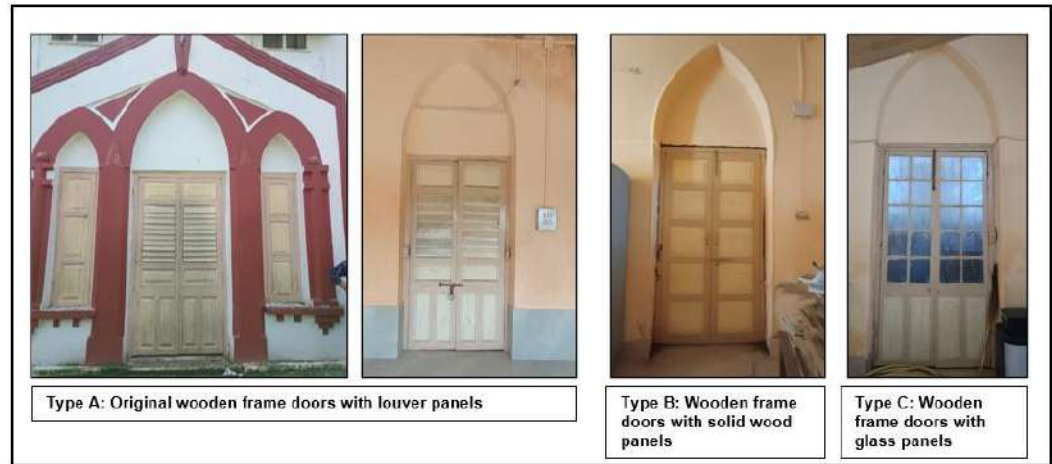
Figure 10: Types of doors in the Library

Condition: Doors with solid wood and glass panels are modifications, while the original louvered doors have largely lost functionality due to multiple layers of paint. In some cases, new louver panels were added with different section details, making them decorative rather than functional. Additionally, wooden frames at several locations exhibit cracks, localized decay, and general wear.

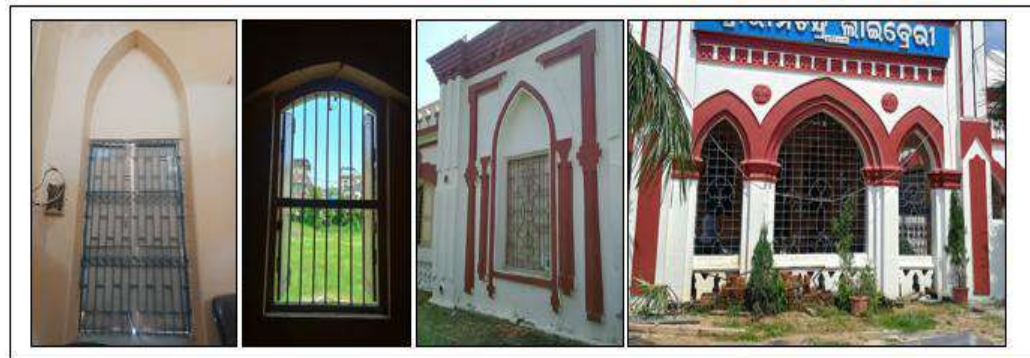
Figure 14:Various Types of Metal Grills used in the openings

Rusting of Metal Grills:

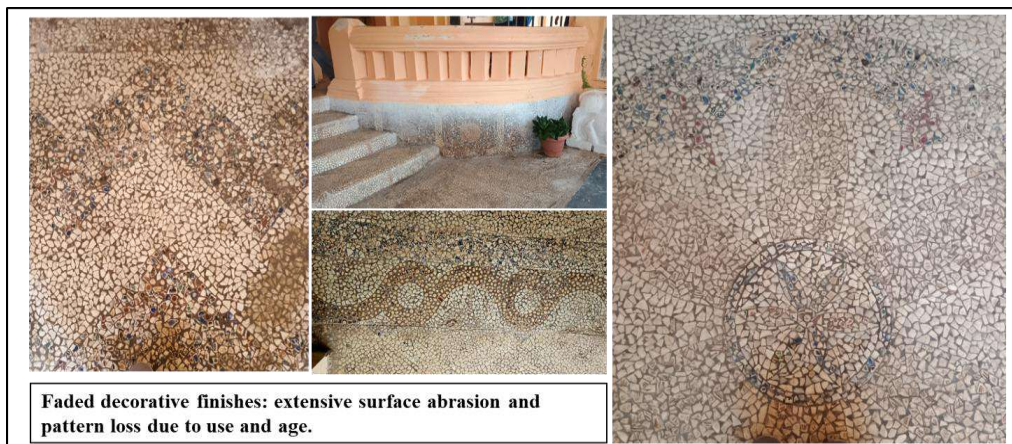
Figure 15: Original mosaic flooring

The original mosaic flooring has been altered in different areas and has been replaced with vitrified tiles. In many years the flooring has experienced surface wear over time and loss in pattern.
